FIRING END ANALYSIS

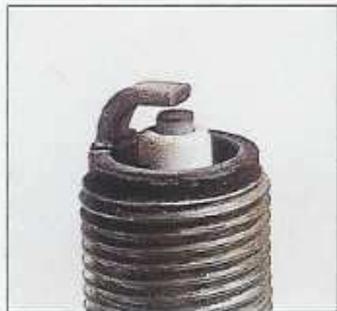
NORMAL

Insulator nose has slight deposits. Colour ranges from brown to greyish-white. Spark plug is functioning correctly under good engine conditions.

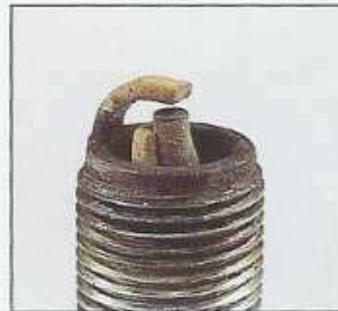
INSULATOR BREAKAGE

The insulator nose is cracked or split. Breakage not resulting from mechanical impact is caused by sudden heating or cooling (thermal shock). Severe detonation will often produce the type of breakage shown in the picture. Causes of detonation are similar to what is described in "Overheated"

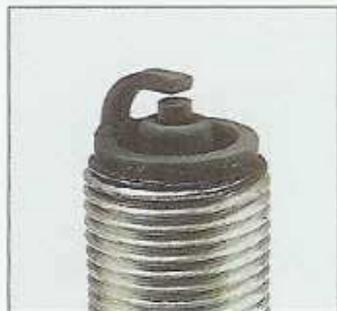
CARBON FOULED

Dry, soft, black carbon deposits form in large quantities on the insulator nose and electrodes. As carbon accumulates the insulation between the centre and the ground electrodes deteriorates, an electrical leakage path is formed by the carbon and misfire results. Causes of carbon fouling include; rich fuel mixture, clogged air filter, faulty choke system, prolonged low speed driving or idling, faulty ignition system, over-retarded ignition timing and spark plug heat rating is too cold.

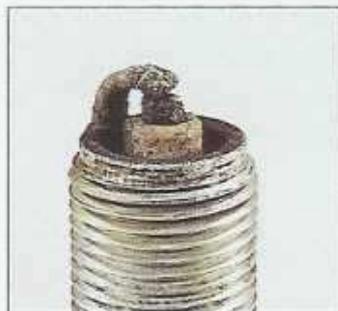
MELTED

The centre and/or ground electrode surface is uneven and cauliflower like in appearance. The insulator is blistered and possibly contains metallic deposits. Melted firing end results from overheating. Refer to "Overheated" for causes.

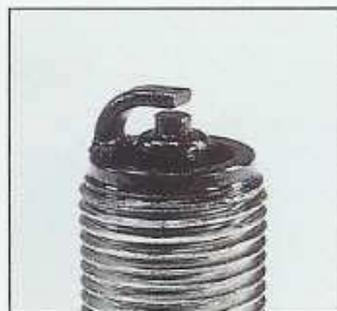
OIL FOULED

Wet, black, oily, carbon deposits form on the insulator nose and electrodes. As described in "Carbon Fouled", misfire results due to the reduction in insulation resistance between centre and ground electrodes. Causes of oil fouling include; excessive oil entering into combustion chamber, oil level is too high, worn piston rings, cylinders and valve guides.

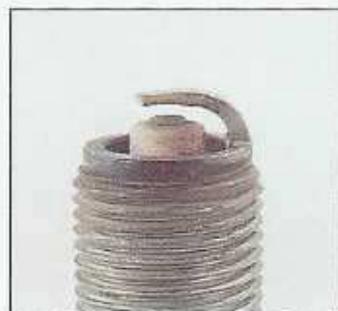
ABNORMAL EROSION

The centre and/or ground electrodes badly worn relative to the length of operation. Misfire will eventually result due to the high ignition voltage needed for the large gap. Abnormal erosion is often caused by harsh lead and oil additives combined with severe operating conditions such as high speed driving.

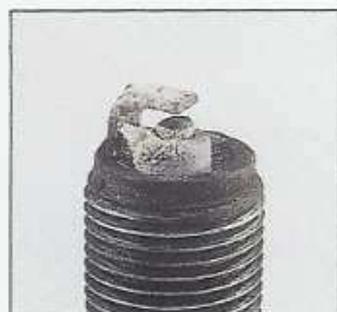
DEPOSITS (Ash Formation)

Heavy ash deposits build-up on the firing end and eventually cause misfire. In some circumstances these deposits can reach temperatures which might lead to pre-ignition. Ash formation is mainly produced from the burning of oil, type of oil, fuel additives and engine condition.

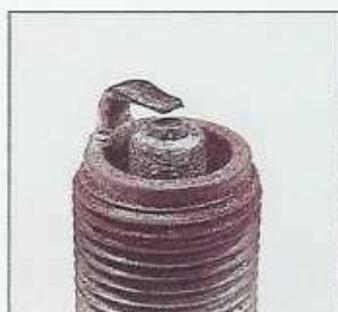
RAPID ABNORMAL EROSION

The centre and/or ground electrodes are very badly worn. Their surfaces are fretted and rough. The electrodes have oxidised and sometimes turn green when the oxidation is heavy. Rapid abnormal erosion is produced by a more aggressive operating environment than "Abnormal Erosion". Refer "Abnormal Erosion" for causes.

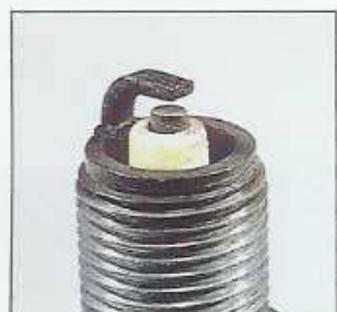
LEAD FOULED

Lead fouling usually appears as yellowish brown deposits on the insulator nose. The lead deposits have no adverse effect on starting, idling or low speed driving but do cause misfire during rapid acceleration or under heavy engine load. Misfire results when the lead deposits become electrically conductive at high temperatures creating a reduction in the insulating resistance between centre and ground electrodes. The lead additives used to enhance the fuel octane rating are the source of the lead deposits. Lead fouling will not occur with unleaded fuel.

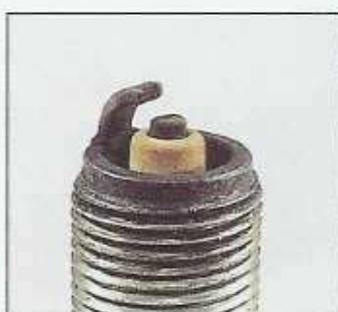
LEAD EROSION

The ground electrode is badly worn and appears to be chipped. Lead erosion is caused by the harsh lead additives in the fuel. At high temperatures these additives chemically react with the nickel alloy electrodes and separate the grain boundary of the nickel alloy.

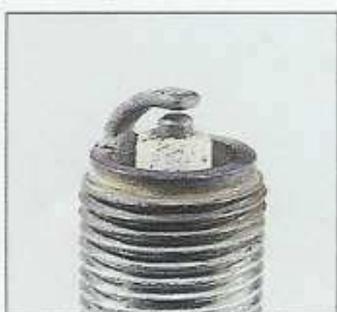
OVERHEATED

Overheated spark plugs have a white glazed or glossy insulator. Small black deposits accumulate on the insulator nose and the electrodes are prematurely worn. Causes of overheating include; over-advanced ignition timing, lean fuel mixture, insufficient fuel octane rating, excessive deposits accumulated in combustion chamber, manifold air leak, insufficient cooling and lubricating, spark plug heat rating is too hot.

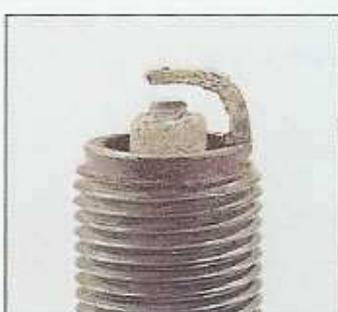
NORMAL WEAR

The centre and/or ground electrodes are worn. Deposits cover the insulator nose and ground electrode. This plug has operated under normal conditions for a considerable period and reached the end of its life. Further usage will cause misfire, bad fuel economy and poor engine performance.
